# GATEWAY

**The Official Magazine of the Gippsland  
Gate Radio & Electronics Club Inc.**

**July 2020**

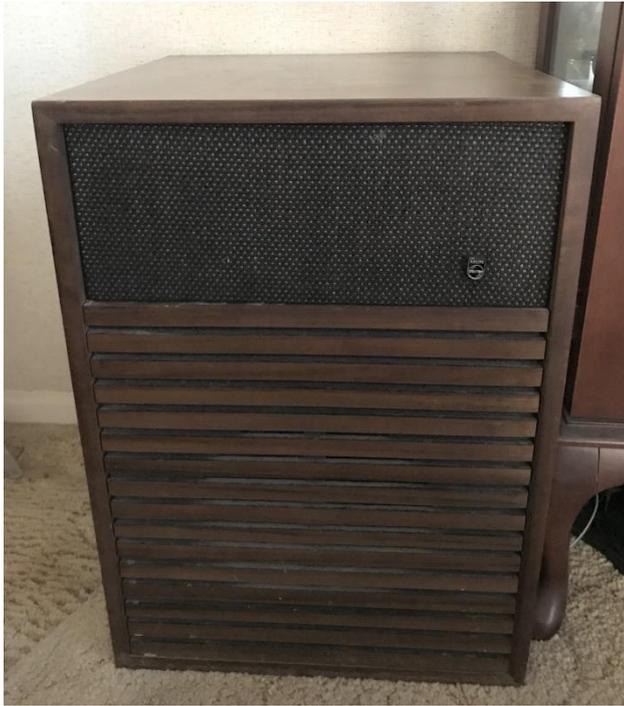
For a while now I have been playing around with speakers, this is my latest acquisition, from a Philips radio-gram from the early sixties.

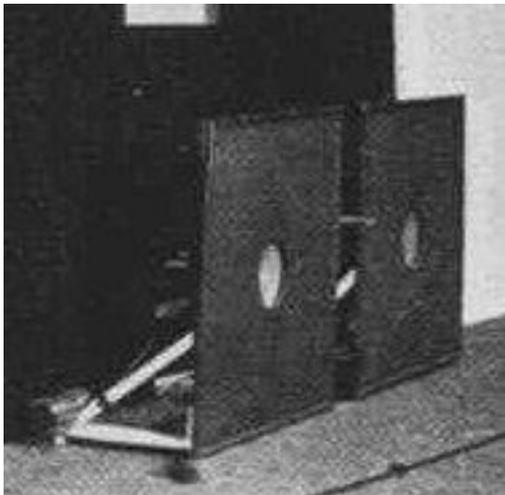
Here are two, propped up in front of a Baird TV demo setup, a 'few years ago' (28/07/1930) in England.

They do lack bass, as the back radiated sound easily wraps around to the front killing the low end, however they are supposed to have a very clean sound as there are no box resonances/boom to taint the sound.

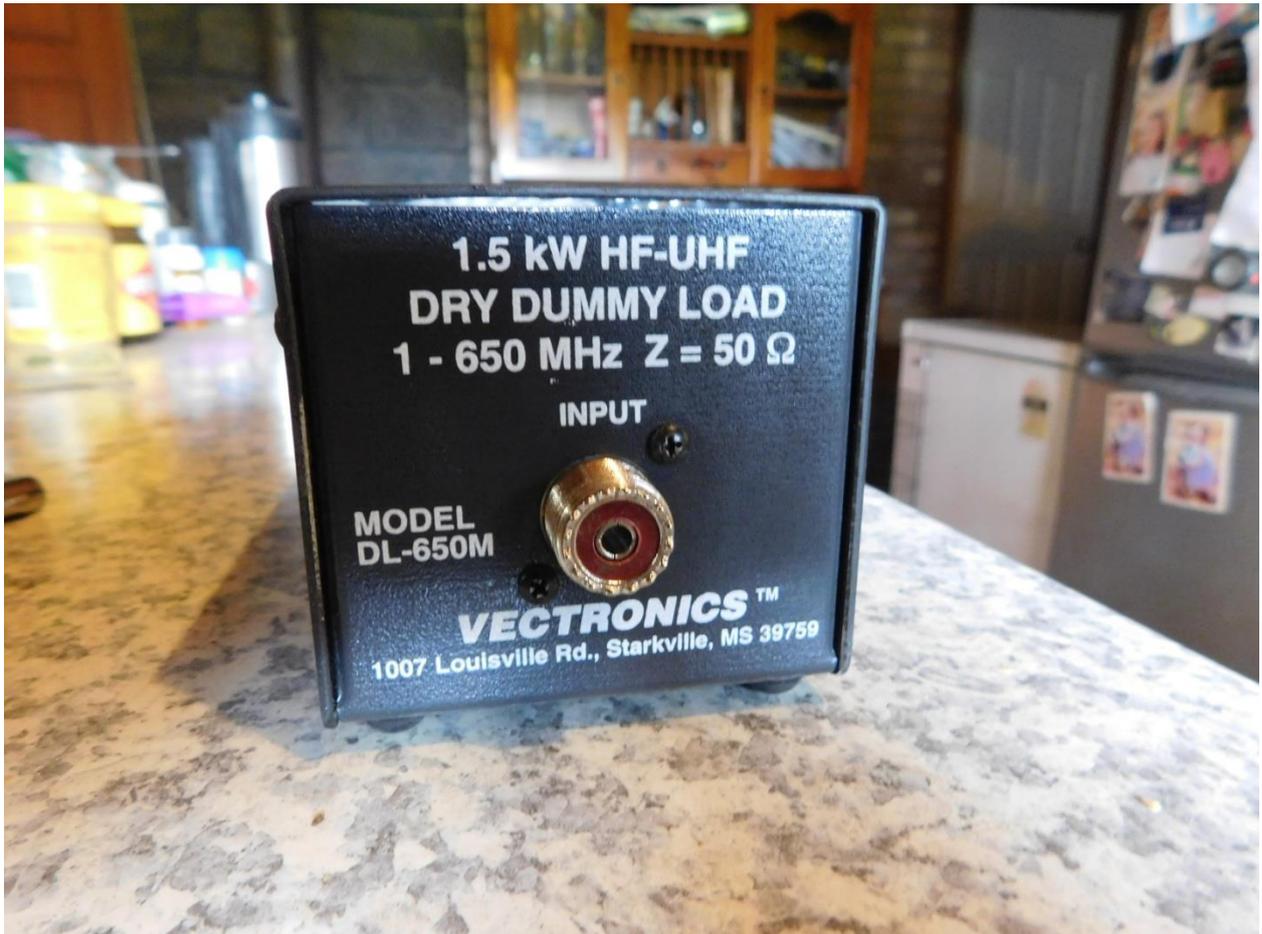
# Vectronics 1.5 KW dry dummy load

Having a few transmitters here at the shack that can comfortably exceed the 400 watt limit I needed a suitably rated dummy load to be able test them at full power, something that I didn't have available. If you remember a few years ago we ran a project at Prac night making some 250 Watt dummy loads which turned out quite well, but even these were not up to scratch for what I wanted to test. I actually tried a 250 watt dummy load on about 3/4 of a KW and the results were not surprising. Twas a thing of beauty to watch the 250 watt dummy load chip slowly vaporize whilst emitting a soft violet glow and giving me enough time to shut the transmitter down before any damage was done. Ok, I needed something better...

After having a look around in the usual places I was still undecided on whether to purchase a wet dummy load or a dry one. Both have their good points as well as their bad points, size, mess etc. so I finally chose an aircooled type from Vectronics. Some of you will notice it is identical to the Mighty Fine Junk line of gear ( which it is 😊 )

Something to think about, apparently these dummy loads make a reasonable "antenna", that is, signals can be heard whilst it is connected to your rig. With this in mind it will probably be a bit "leaky" on transmit so caution needs to be exercised when transmitting. For the price ( \$125 ) the Vectronics dummy load is a handy addition to the shack.

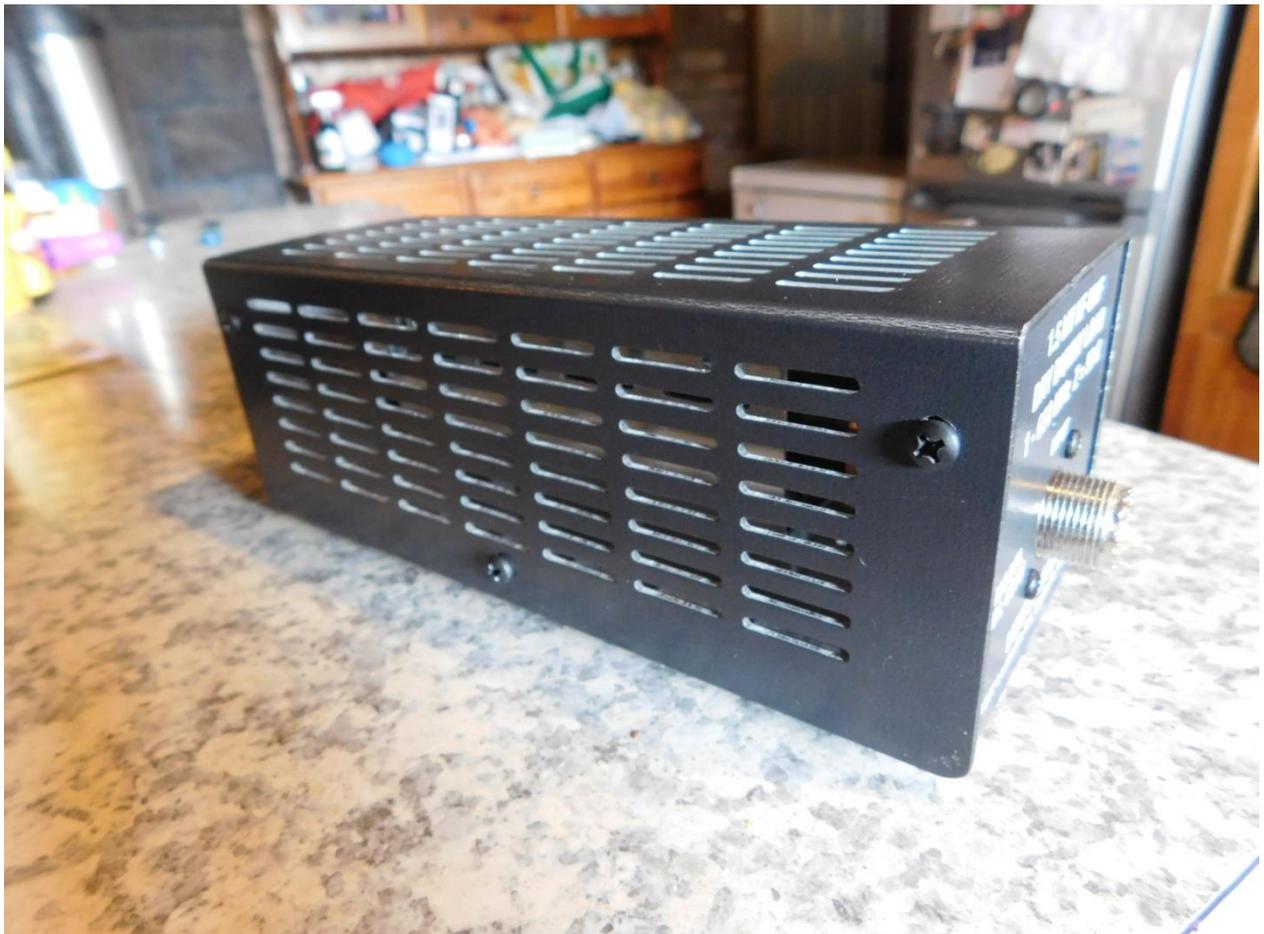
Before using the dummy load I carried out some sweeps of it and confirmed that it would be ok to use at some fairly substantial RF power. Below are the results.

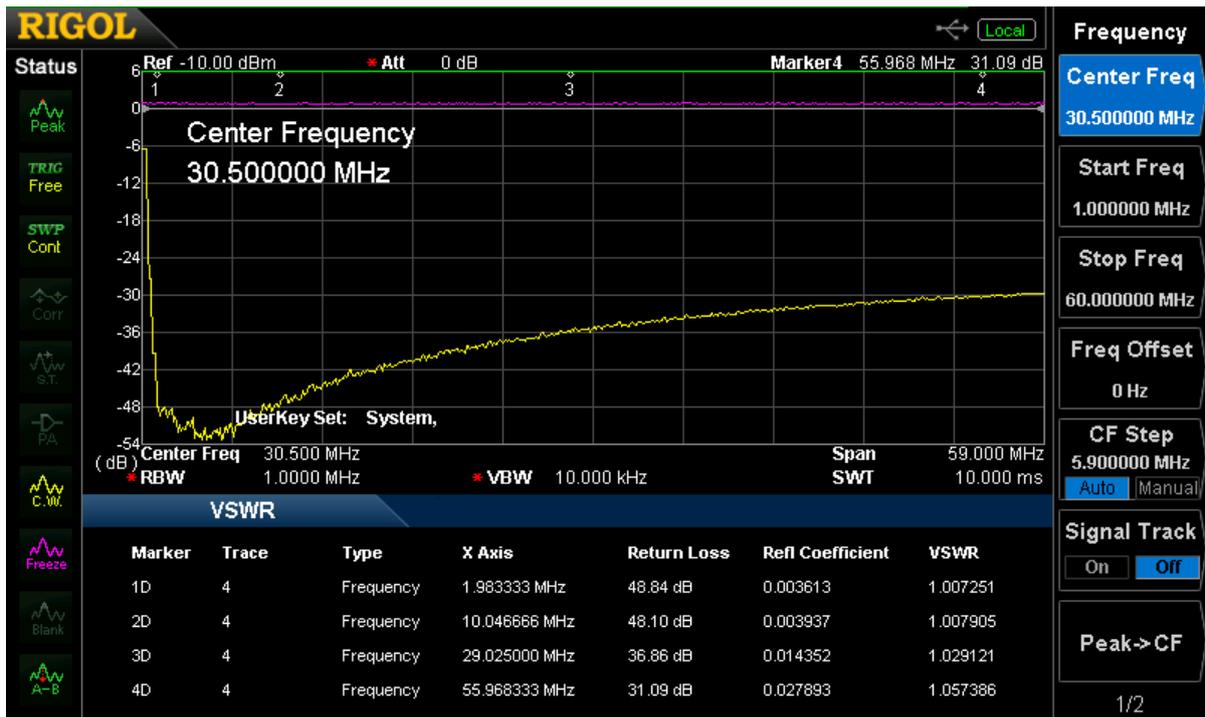
On the above sweep I “marked” four frequencies of interest; they were 2 MHz, 10 MHz, 29 MHz and 56 MHz. All four frequencies showed a VSWR lower than 1.05 to 1. We were off to a good start !

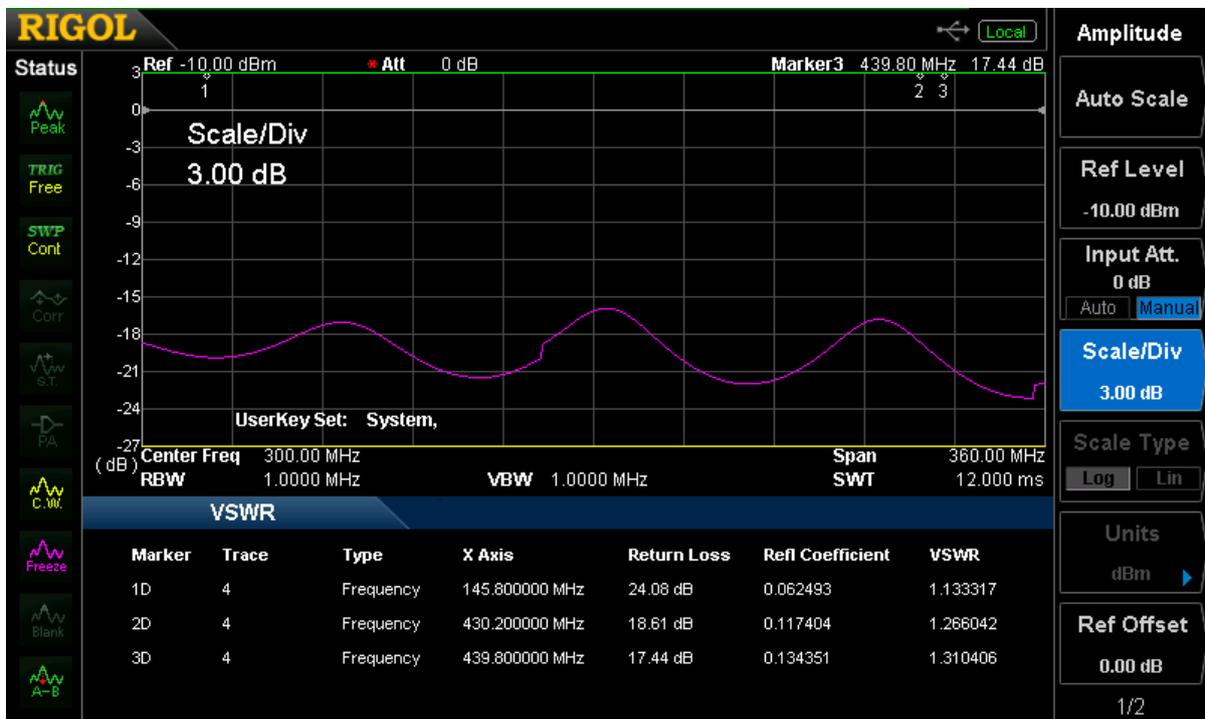
On the above sweep I tested 2M and 70cm, 2M came in with a VSWR of 1.13 to 1 and 70cm came in with a VSWR 1.31 to 1. Just for fun I swept the dummy load at 23cm to see what the results would be. As I expected, no good, after all the load is only rated up to 650 Mhz.

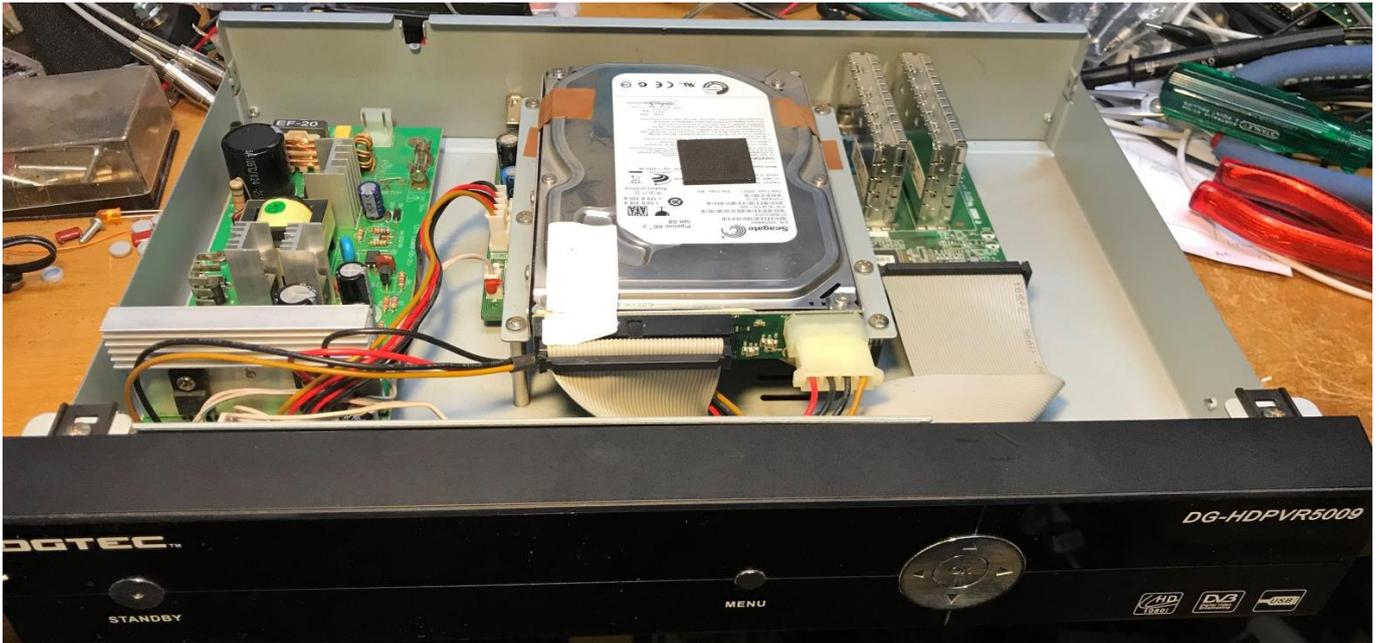
# PVR Repairs

This unit appears to have succumbed to a power failure, well that's what its owner reported to me. I kind of suspected the power supply, capacitors in particular slowly degrade over time, however if the power is left on, they can tend to offer just enough for the equipment to keep running. However faced with a few hours of no power they soon loose whatever little they have and the equipment will never run again.

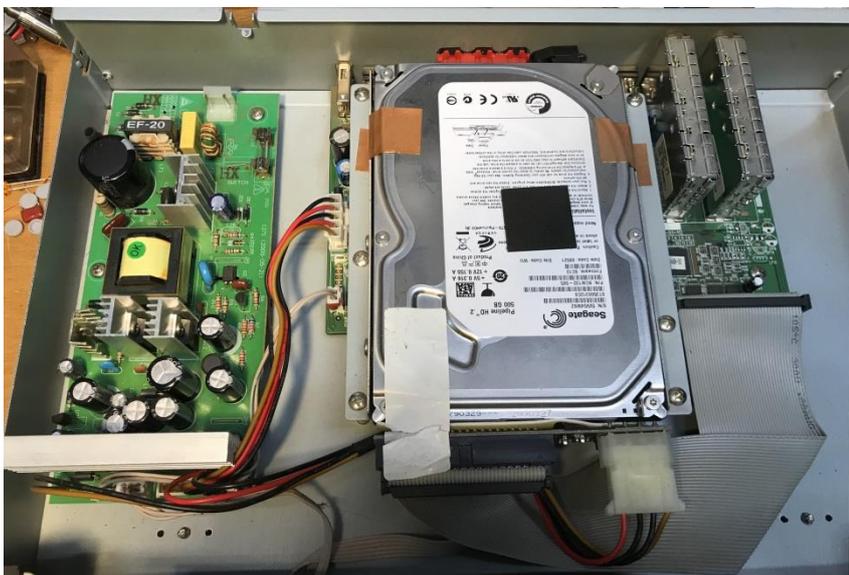
This PVR does have a standby button, however it does little, and does even less to the power supply that just pumps out 3.3, 5, & 12V as long as it is plugged in.

Another view inside, there is not much to it; admittedly a fair bit is hidden under that 500 gig HDD.

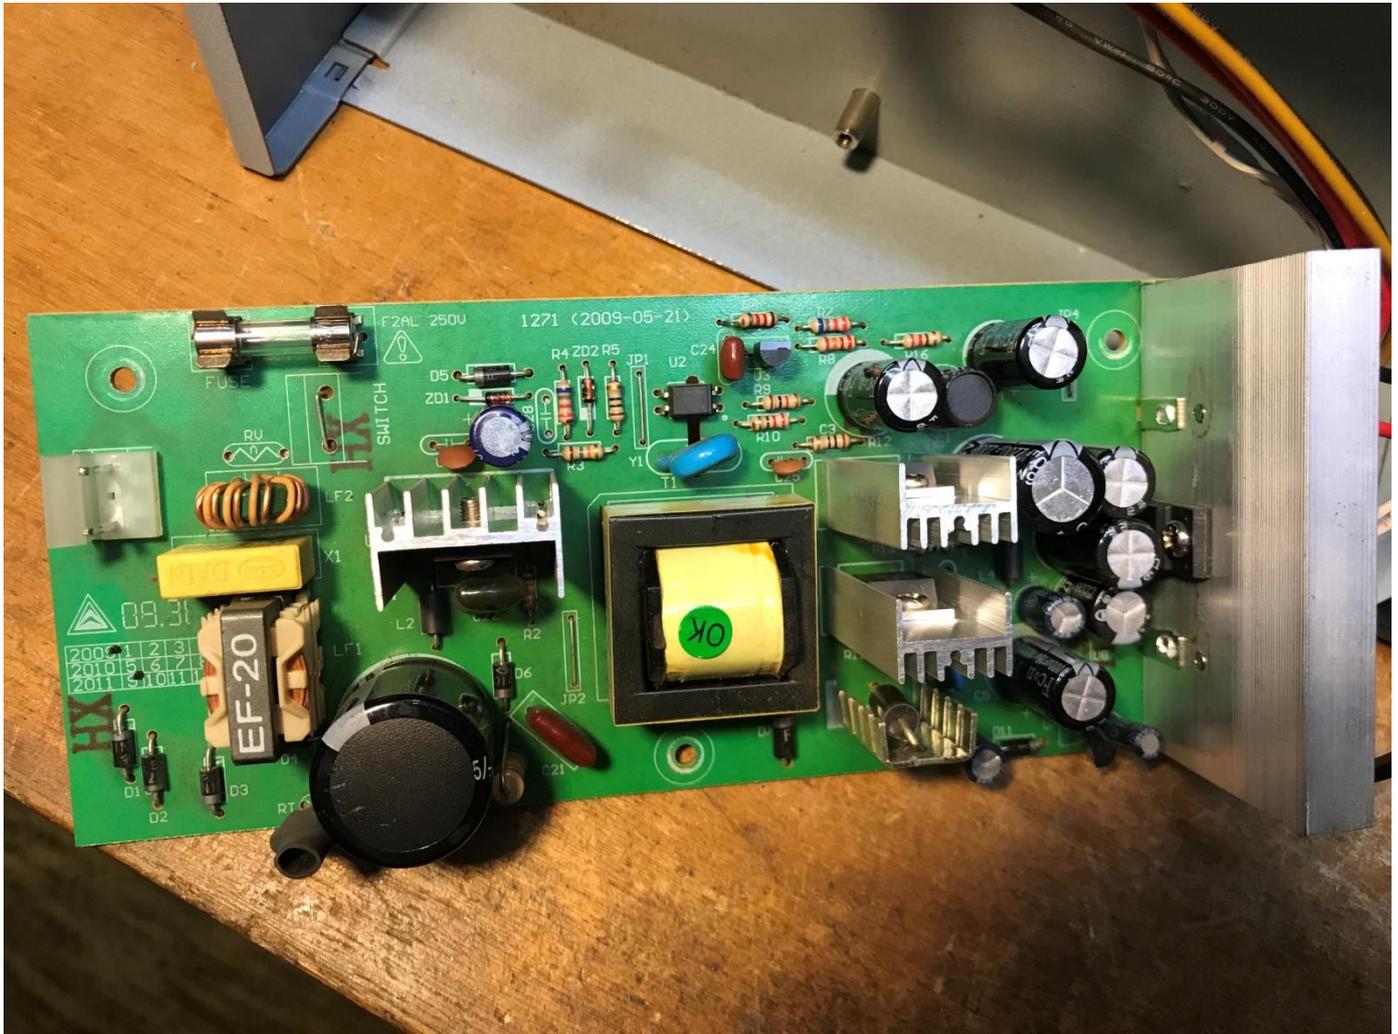
And here is the power supply, luckily easily extracted. The output cable to the main board had me a tad confused, it had two red wires, nothing unusual, a common trick done to lower the resistance & up the current, however my meter indicated that they were not connected to each other, unlike the two black wires.

So I disconnected everything and powered it up, a somewhat risky manoeuvre as sometimes these supplies lose the plot and the rails shoot through the roof, followed shortly by lots of smoke signals. Luckily I got away with it, and discovered that one red was 5V, whilst the other was 3.3V. Usually denoted by different wire colours, not this time, however they did shout a different colour for the 12V rail (yellow)

I then powered it up with just the hard drive and its adapter board, the rails were a bit down, and a look with my oscilloscope showed signs of 100Hz ripple appearing. Now the only caps that will be affected by the 50Hz mains are the main filter cap, and another small 10uF 50V cap. Small electro's like this (small values, with high voltages) tend to die the first, so replacing that one soon had it all working.

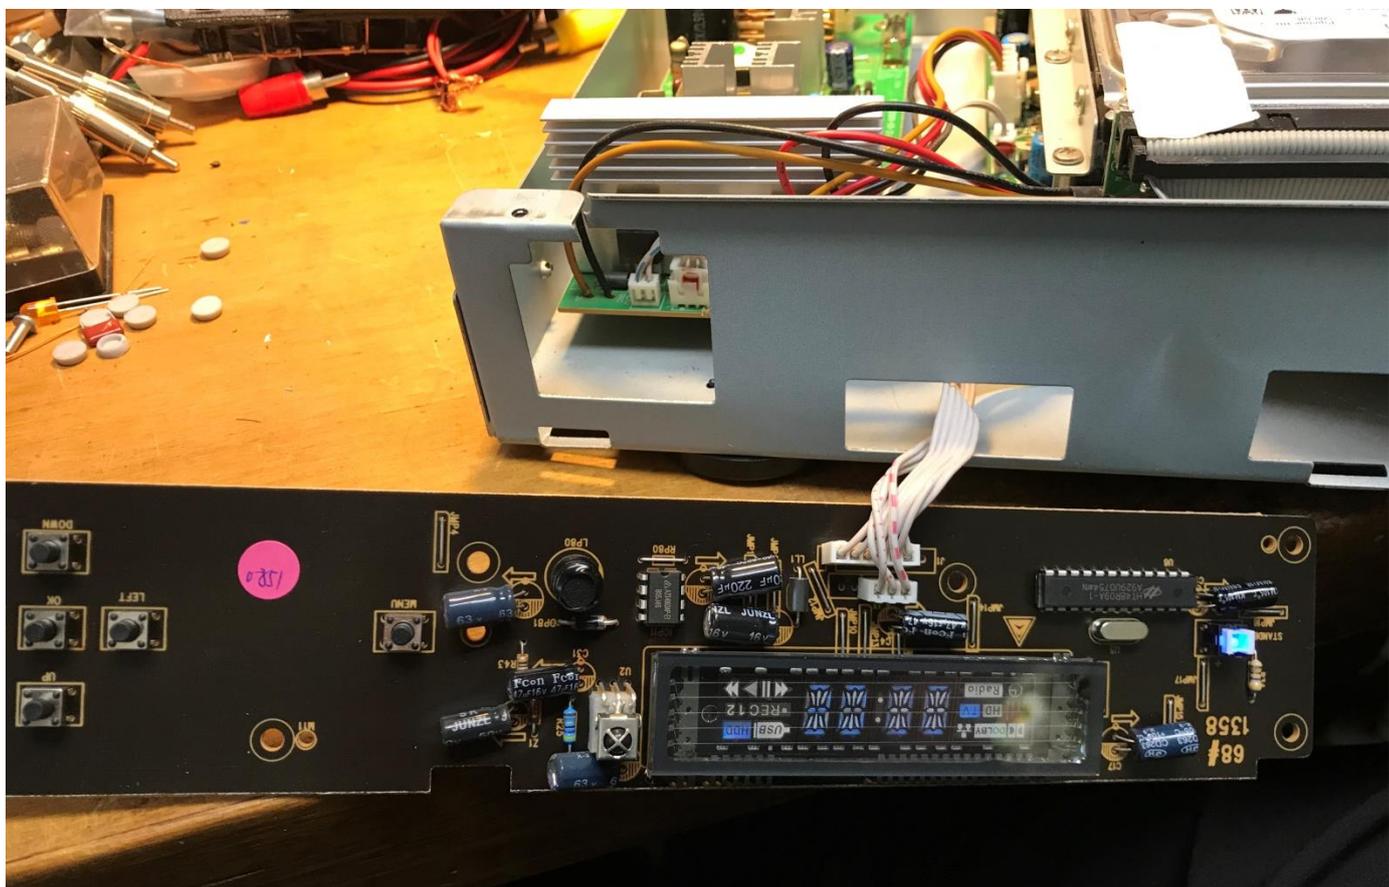
As you can see, it is awfully dim. Looking at the front panel you could almost think it did not have a display at all, it is that dim

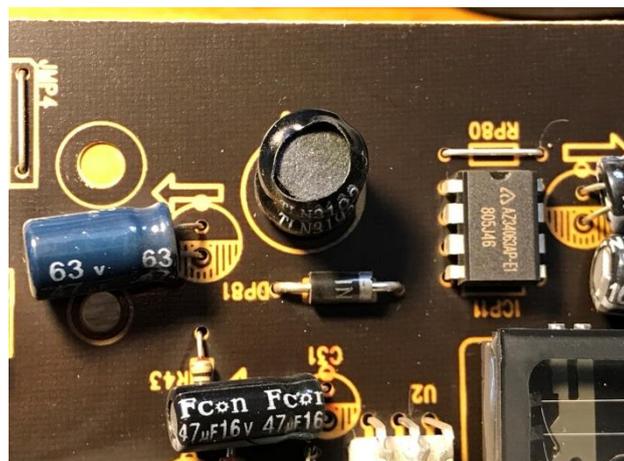
Being a vacuum tube, there are two supply rails, one for the filaments, usually a few volts, and another, typically about 30V, or there about's. Funny, I had just been playing with the supply and I didn't spot any higher voltage rails.

In this unit, they were using a small step up supply with an 8 legged IC, an inductor a diode, and the obligatory filter cap to give us the high voltage. This all appeared ok with no ripple when inspected with my 'scope, so this part is ok.

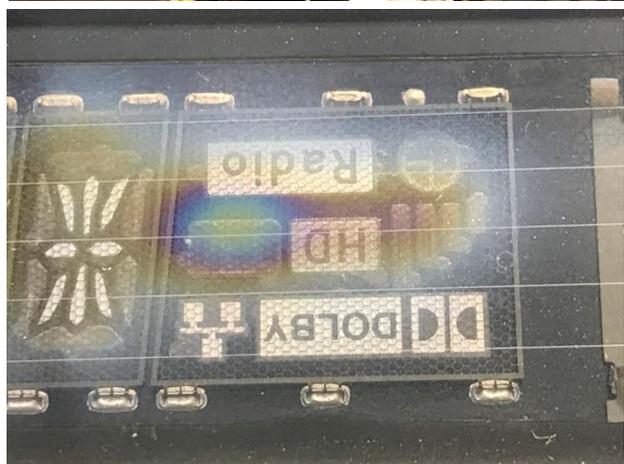
Closer inspection of the display however revealed that it was absolutely clapped out. You can see what looks like a metalized plating between the 'HD' and the first digit. That area is another square indicator, like the 'HD' one, that says 'TV'. It appears to be always on. The phosphor is all but gone, and what's left is masked by that plating. The adjoining digit does have top and bottom segments, again masked and totally hidden.

The likelihood of getting a new one is zero, so sorry, no fix here. Yes I could bodge in something, but the owner will not like the bill for all the hours involved, so that's it, job done.

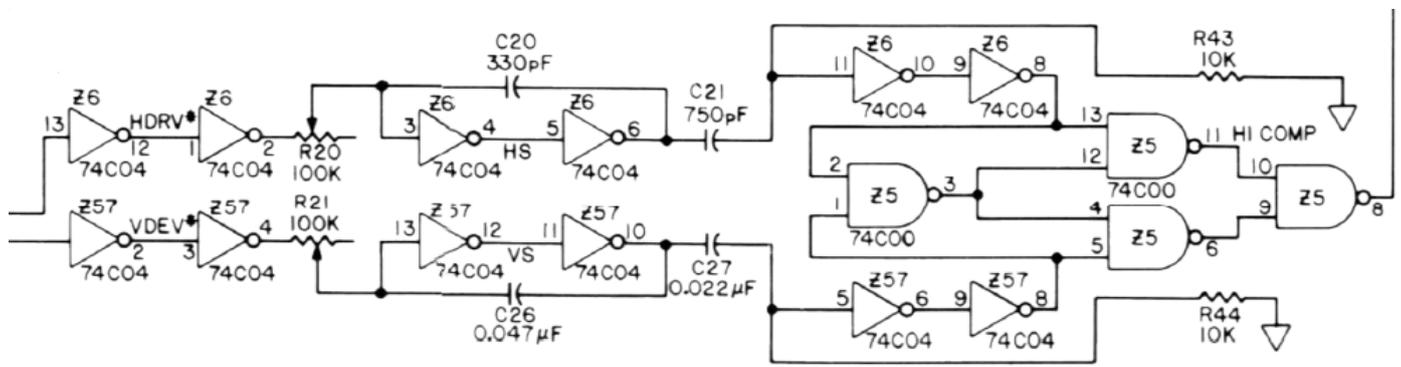
*This is part of the sync circuit, the bit that feeds the 'SYNC' line in the previous circuit.*

The input is two pretty much square waves, one for the vertical sync (50Hz?, via Z57), the other for the horizontal sync (15.6KHz, via Z6). This circuit converts the square waves into pulses and then combines them into a composite sync signal (Z5), ready to be mixed with computers 'graphics' to give us composite video, as required by the video monitor.

The horizontal was fine at Z6, pin 8, however the same could not be said for the vertical, Z57, pin 8 was stuck, only changing states after that weird 2 second startup carry-on. Moving back down the train with my oscilloscope soon struck gold at Z57 pin 6, with the presence of my probe completely changing things. A scope probe is normally 1 megohm, and should not have much effect on a 50Hz signal. However the real indicator of what was going on was when I touched that pin with my finger, the stay 50Hz mains hum in me made that circuit kind of spring back into life. It restored a picture to the screen, albeit one somewhat out of sync, but a picture nonetheless.

This indicated that pin 6 was high impedance (because I could easily couple into it, and the 1M scope had a big effect) whereas the output stage at pin 6 should have made it low impedance.

Obviously the output stage of that gate was blown wide open, time for a new 74C04.

Whilst a 74C04 and a 4069 appear to be identical on paper, having the same logic functions (6 CMOS inverters), I never assumed the similarity's would go that far, especially in this application as you can see from the above circuit, there are a few caps etc., forming delay and pulse generators, any variation in IC parameters could easily upset things making the whole stage go somewhat haywire. I have seen the odd design where they even stipulate the brand of gate to use, otherwise trouble. So when I see stages like above, I am weary of any substitutes.
